Gariep Watch

QUARTERLY WATER QUALITY SURVEY ON THE LOWER ORANGE RIVER DECEMBER 2020 SURVEY

Report reference: ORANGE/A/2021

First draft
16 FEBRUARY 2021

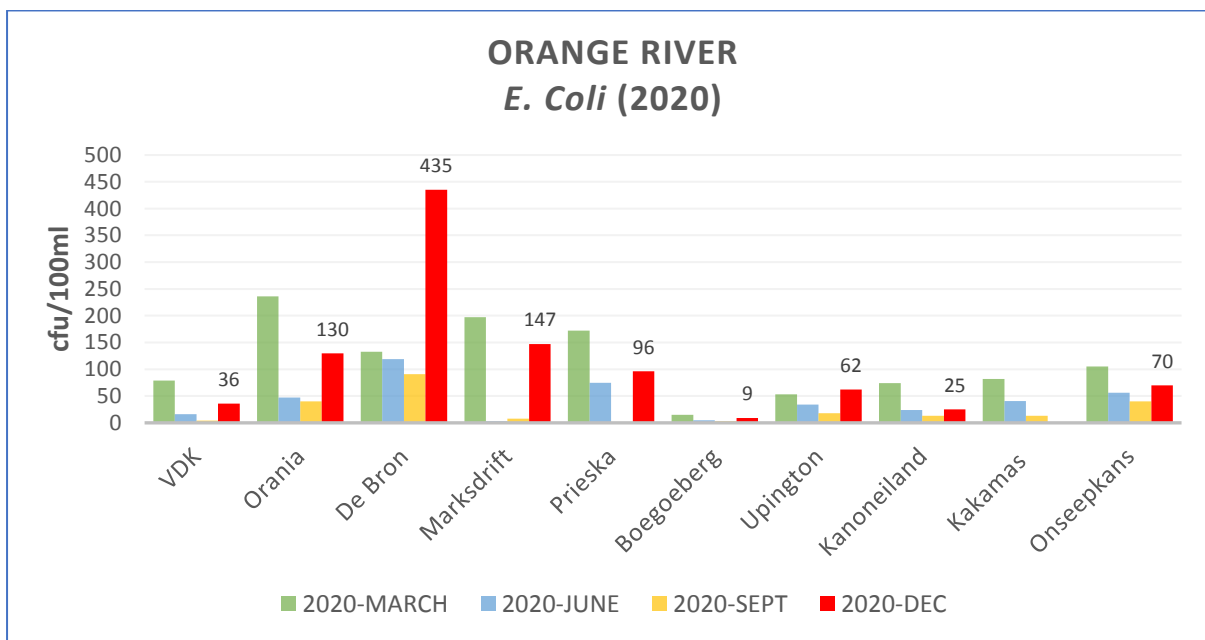
Figure 4: Recorded E. coli – 2020 data.

Figures 3 and 4 illustrate the E. coli recordings for the entire database period and for 2020 respectively. Database high E. coli values were recorded at De Bron downstream from Hopetown during December 2020. The Orange River section between Orania and Prieska is undoubtedly heavily contaminated with untreated sewerage effluent and the main source is from the Hopetown sewerage works.

Water quality at Marksdrift is important as this water comprises much of the irrigation and potable water that is used in the Douglas area. An E. coli count of 147 cfu was recorded during December 2020 as shown in Figures 3 and 4. A significant source of bacteriological contamination was found upstream from Marksdrift at Hopetown during the November 2020 pollution source survey. This is the most significant point source of contamination in the lower Orange River catchment and should be resolved as soon as possible.

Prieska is the first downstream monitoring locality after the Orange- and Vaal River confluence. Figures 3 and 4 show that the Prieska sampling locality mirrors the raised bacteriological counts from the upstream Hopetown area.

There is a long and fairly uninhabited stretch of river between Prieska and Boegoeberg. Natural treatment processes in the river reduces the bacteriological concentrations significantly as observed in Figures 3 and 4.

There has been a marked decline in E. coli counts at most lower Orange River localities during the first three surveys of 2020 as shown in Figure 4. Figure 3 also show a temporal decline in E. coli counts at Orania, De Bron and Boegoeberg since the inception of this monitoring programme. This trend was reversed during December 2020 with raised E. coli throughout the lower Orange River including Upington where a high E. coli count of 62 cfu was recorded.

The E. coli count increased to 70 cfu as compared with 40 cfu during September 2020. This increase was noted throughout the lower Orange River as shown in Figures 3 and 4.
